DAGVATTENFÖRDRÖJNING – GRÄSYTA MED KOLMAKADAM

## Bo Bergman Gata 2016 Biochar with infiltration of stormwater

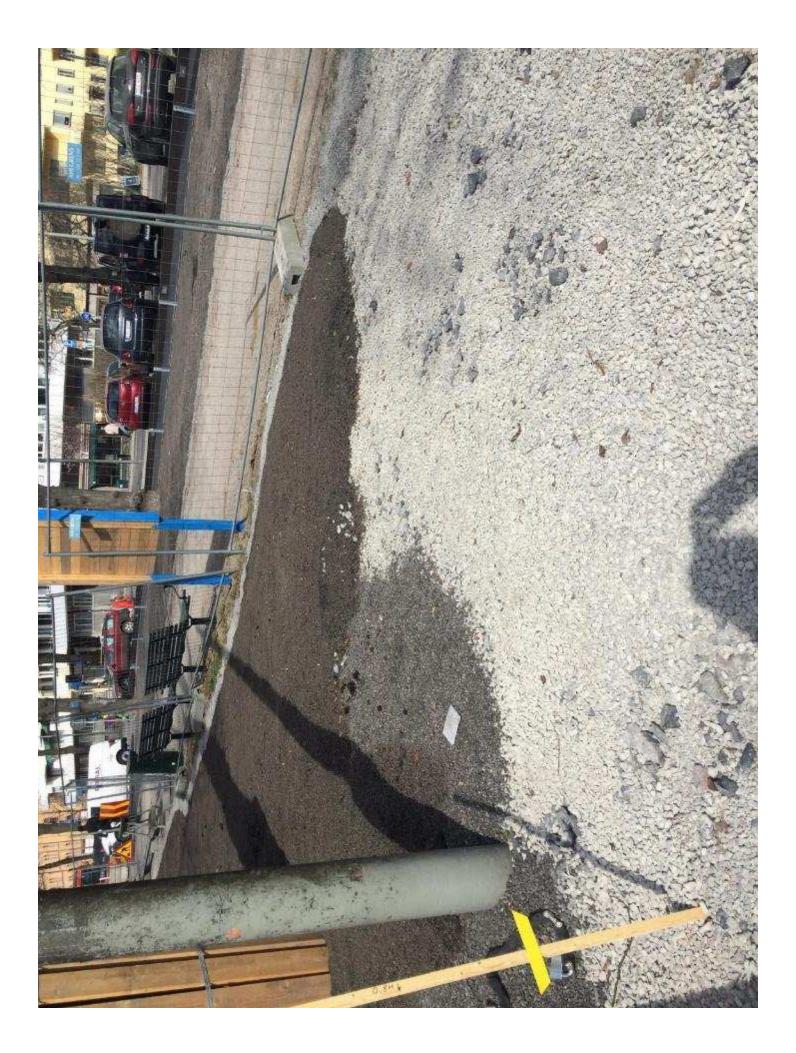
2-6mm 3 parts 1 part biochar100mm and grass seeds on the surface

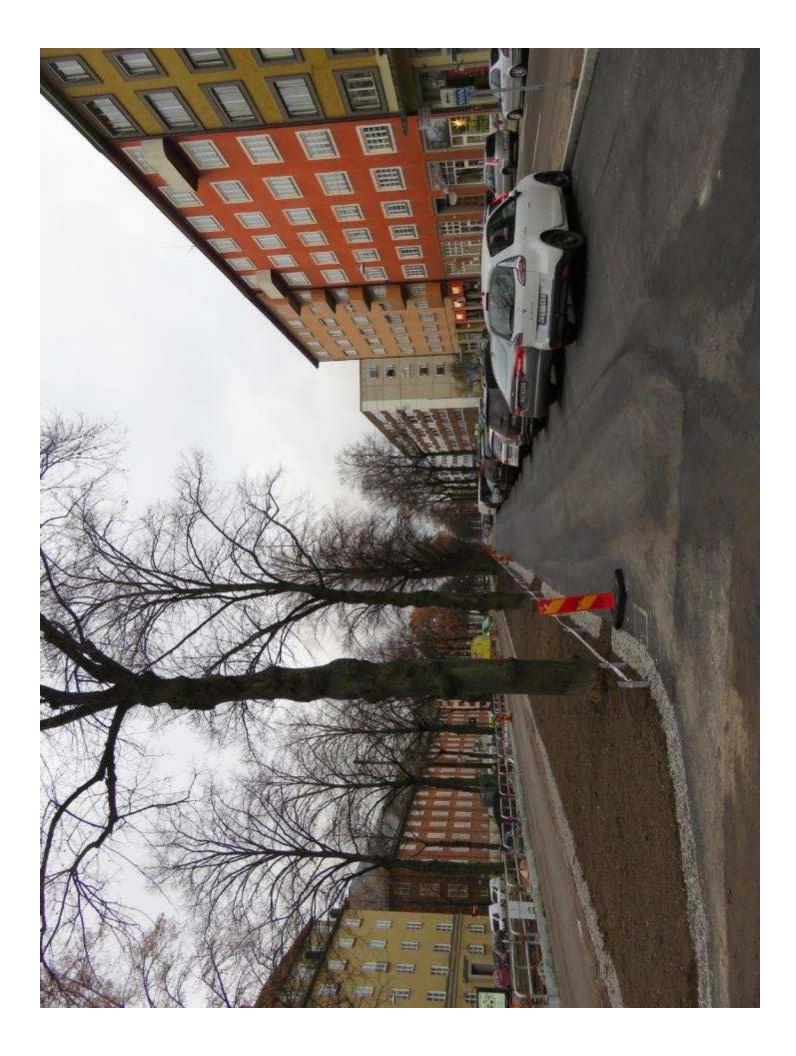
•Plant bed renovation a block of Tilias

•The stone and biochar are mixed before the material is laid down, 15% by volume biochar.

•Closest to the roots of saved trees added a mixture of crushed granite and 25% manured biochar.
